SIX SIGMA • DMAIC PROJECT

# Eliminating Open Anti-Back Defects on Toyota Wire Harness Lines

Sumitomo Electric Wiring Systems, Egypt • May – Sep 2023

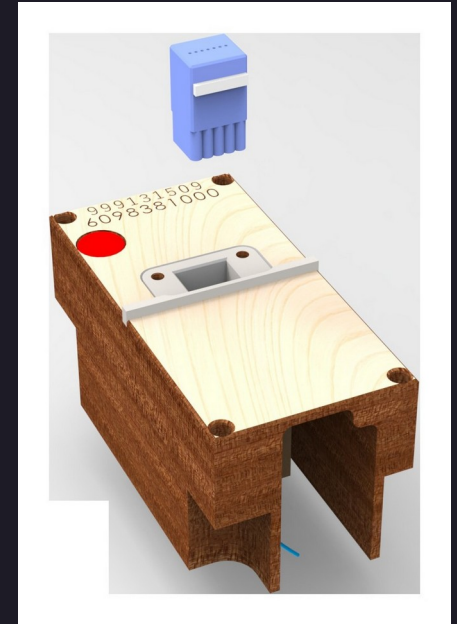
Redesigned test jig: our breakthrough idea

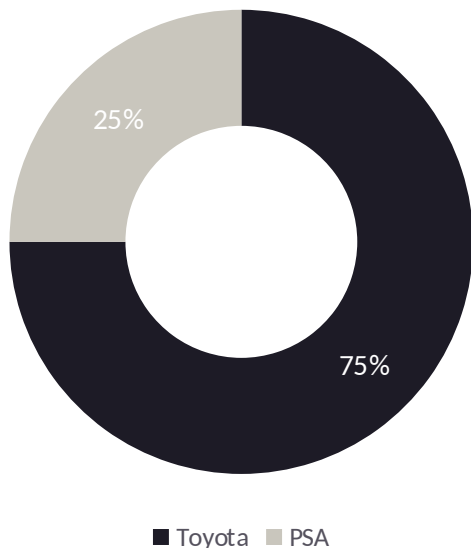
Official customer concerns, 2022/23 (n = 52)

# Toyota drove 75% of customer concerns

traced to open anti-backs that caused terminal back-out at the customer.

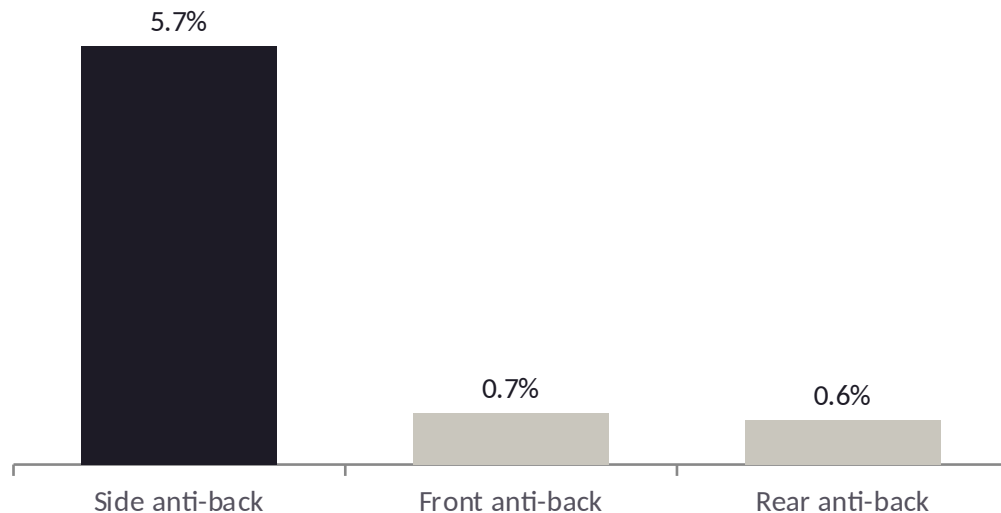
Baseline: defects as % of internal defects, May-Jun 2023

# 81% of anti-back defects came from side-type connectors

- Defects split by anti-back position: side, front, rear
- Operator survey: unclear instructions, board passing open anti-backs, hard-to-close latches
- Test-jig check: a 1 mm semi-open anti-back still passed

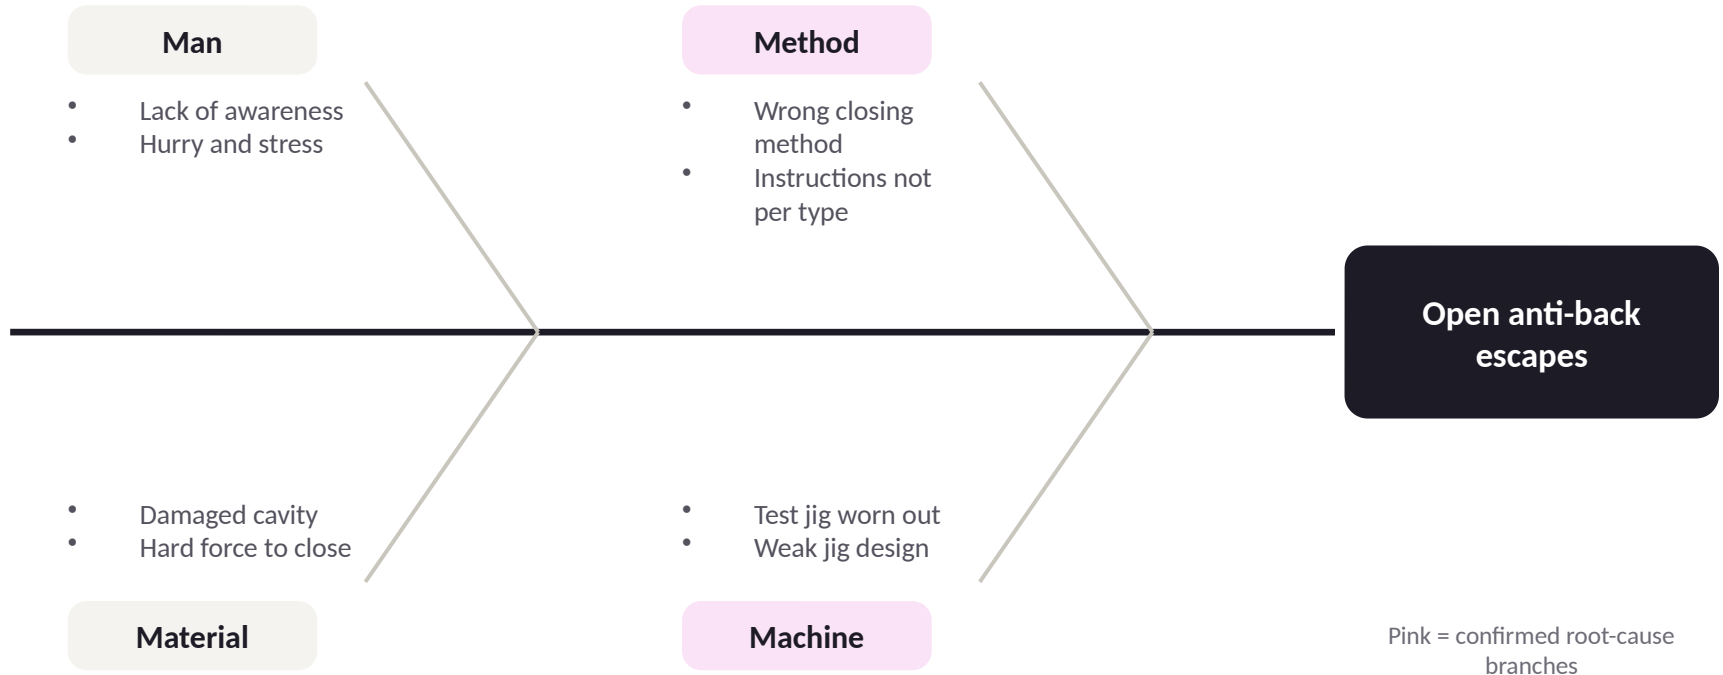
# 4M analysis: where the defect comes from

Operator did not close the anti-back correctly

Standard closing method not followed

Closing method differs by anti-back type

**Training was not dedicated to each closing type**

Electric test board passed an open anti-back

Detection cylinder had a loose nut; jig wore out before monthly PM

Jig needed continuous corrective maintenance

**Test-jig design had weak points and missed 1 mm semi-open**

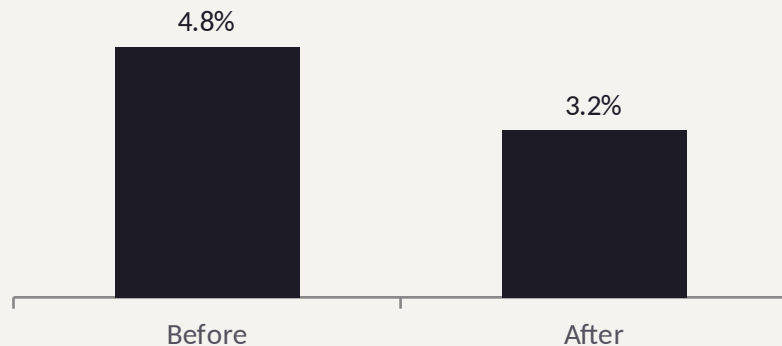
Side anti-back, % of internal defects

# Countermeasures 1 and 2 helped, but did not reach the goal

## 2 • Re-tune the test jig

Cylinder stroke set against a sensor so only a closed anti-back passes; weekly jig risk assessment.

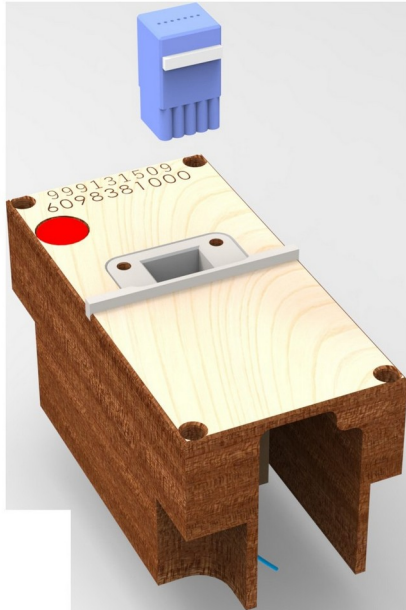
## Countermeasure 3: a two-cylinder jig with a 3-second timer

**Before:** zero-delay cylinder risked passing an open anti-back. **After:** open anti-back cannot pass.

moves in until sensor 1 detects the connector body

timer delays the spacer cylinder, as the supplier recommended

slides over the anti-back; sensor 2 passes only a fully closed latch

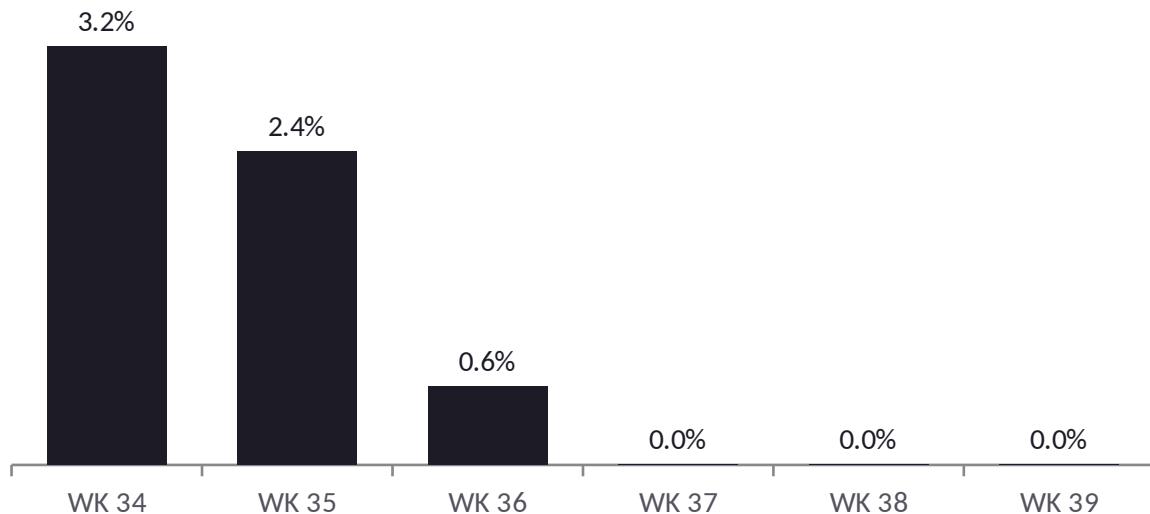
Side anti-back, % of internal defects (CHR roof, right door, left door)

# Pilot result: side anti-back defects hit zero by week 37

side anti-back defects from  
WK 37 to WK 39
