# Quality Circle

## Kami Kaze Team

**Theme : Preventing Annoyance Defects**

**Activity Base:** SEWS-EG (6th October)

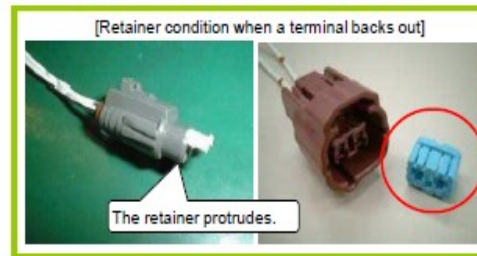
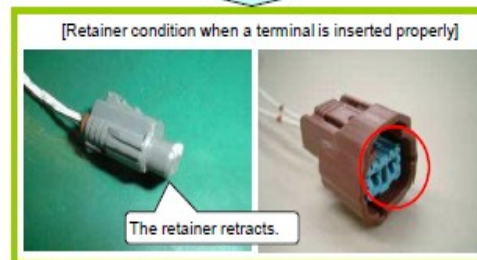
- Because both the connector and retainer are made of resin, the retainer is not inserted even if the terminal backs out when the retainer is pushed in forcibly. **Interference**
- Never have too much confidence in the connector configuration.

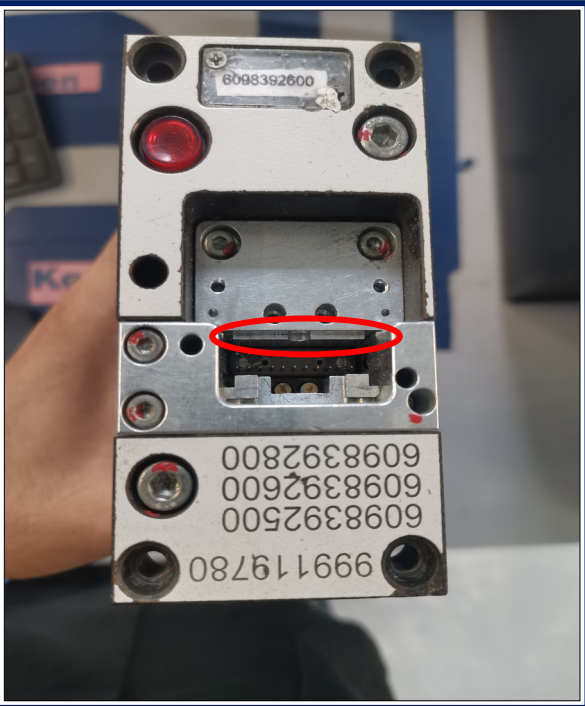
## How it Works ?

If the anti-back Open, it will push the Pallet as shown to activate the Spacer-Open detector so it wouldn't Pass.

## Weakness Point

This Design Can't detect Semi Open anti back with 1 mm

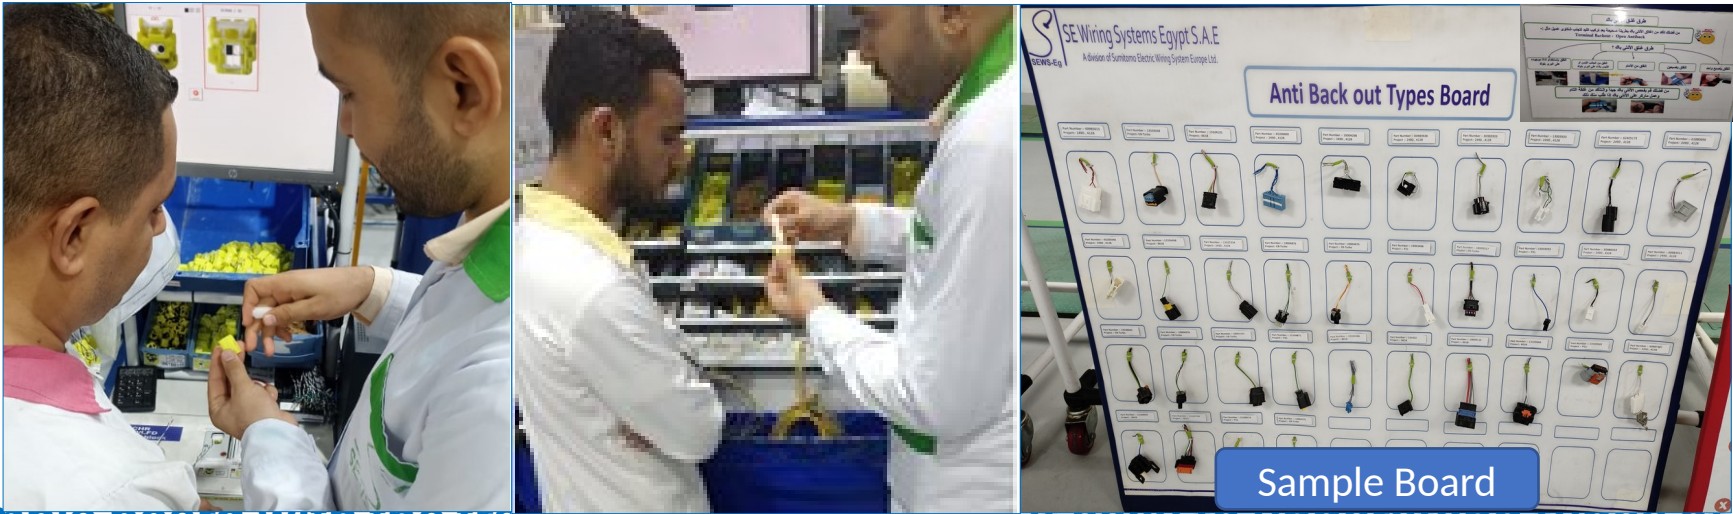
1<sup>st</sup> solution: Training Operators

We used a sample board with the training manual to make it easy to understand types of anti-backs (side anti-back , front anti-back & rear anti-back ) regarding to anti-back position and the different methods to close it.

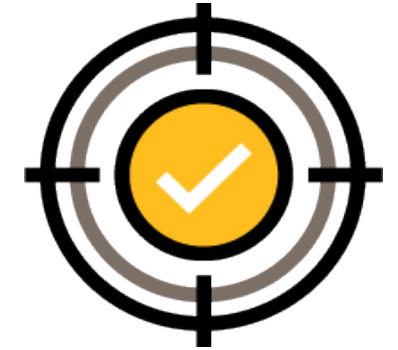
# Productivity

Average time: 125 seconds

**After** Electric cycle time: 123 seconds

### Cycle Time For Electric Test Board Per Second
